Manhole Inspection Summary

Manhole # S21II_058MH

Location Address: **1701 MOUNT-FULTON ALLEY**

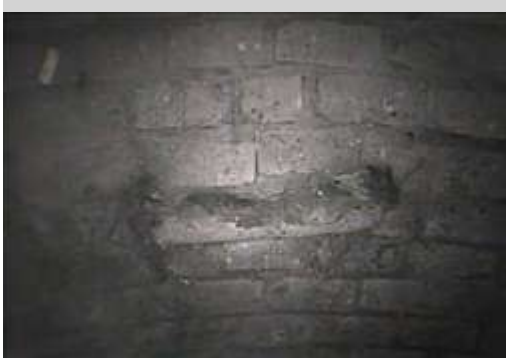
Defect 2

☒ **Evidence Of Surcharge**

Depth: **3** (ft.) ☐ Active Surcharge Present

SURCHARGE EVIDENCE

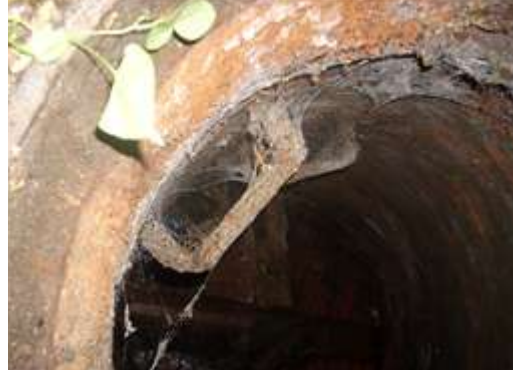
Defect 1

Count: **5** Missing: **0** ☒ **Corroded**

CORRODED STEPS

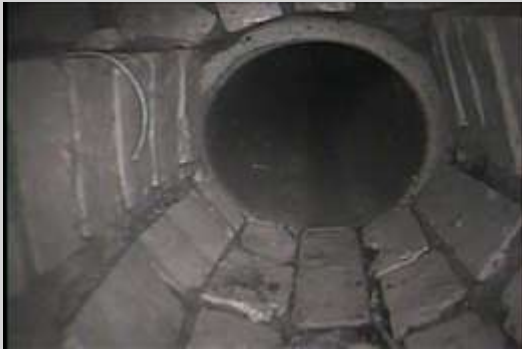
12 O'Clock Outflow

8 in. Circular Gravity Sewer
Pipe Out @ 12 O'Clock

SURCHARGE EVIDENCE

Pipe Height: **7.2** (in.) Rod and Bar (Angled)
Pipe Material: **Clay** ☐ Pipe Lined
Invert Depth: **9.94** (ft.) Flow Characteristics: **None**
Deposits: ☒ None ☐ Mud ☐ Sludge ☐ Debris ☐ Grease
Silt Depth: (in.) Deposits Extent:
Infiltration: **None** Pipe Seal Cond: **Sound**

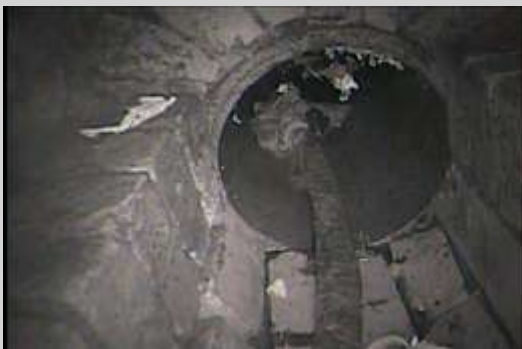
3 O'Clock Inflow

8 in. Circular Gravity Sewer
Pipe In @ 3 O'Clock

Pipe Height: **8.4** (in.) Rod and Bar (Angled)
Pipe Material: **Clay** ☐ Pipe Lined
Invert Depth: **9.61** (ft.) Flow Characteristics: **None**
Deposits: ☐ None ☐ Mud ☐ Sludge ☒ **Debris** ☐ Grease
Silt Depth: **1** (in.) Deposits Extent: **Light**
Infiltration: **None** Pipe Seal Cond: **Broken**

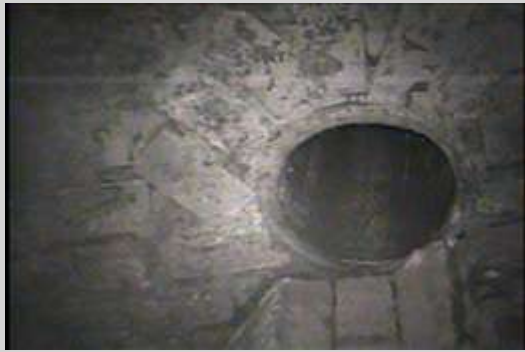
6 O'Clock Inflow

6 in. Circular Gravity Sewer

Pipe In @ 6 O'Clock

Pipe Height: **6** (in.) Rod and Bar (Angled)

Pipe Material: **Clay** ☐ Pipe Lined

Invert Depth: **8.13** (ft.) Flow Characteristics: **None**

Deposits: ☒ None ☐ Mud ☐ Sludge ☐ Debris ☐ Grease

Infiltration: **None**

Pipe Seal Cond: **Sound**

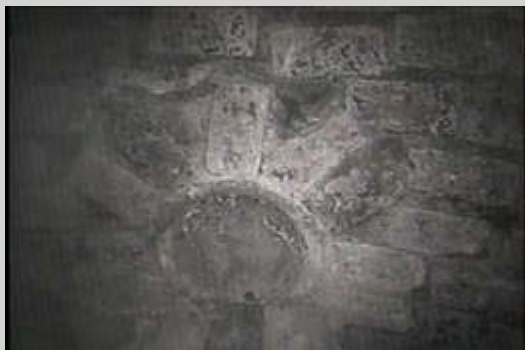
9 O'Clock Inflow

6 in. Circular Gravity Sewer

Pipe In @ 9 O'Clock

Pipe Height: **6** (in.) Rod and Bar (Angled)

Pipe Material: **Clay** ☐ Pipe Lined

Invert Depth: **8.41** (ft.) Flow Characteristics: **None**

Deposits: ☒ None ☐ Mud ☐ Sludge ☐ Debris ☐ Grease

Infiltration: **None**

Pipe Seal Cond: **Sound**
